Parcel C (Parcels C and UC-2)
Five-Year Review Site Inspection Photograph Locations
Five-Year Review of Remedial Actions
Hunters Point Naval Shipyard, San Francisco, California

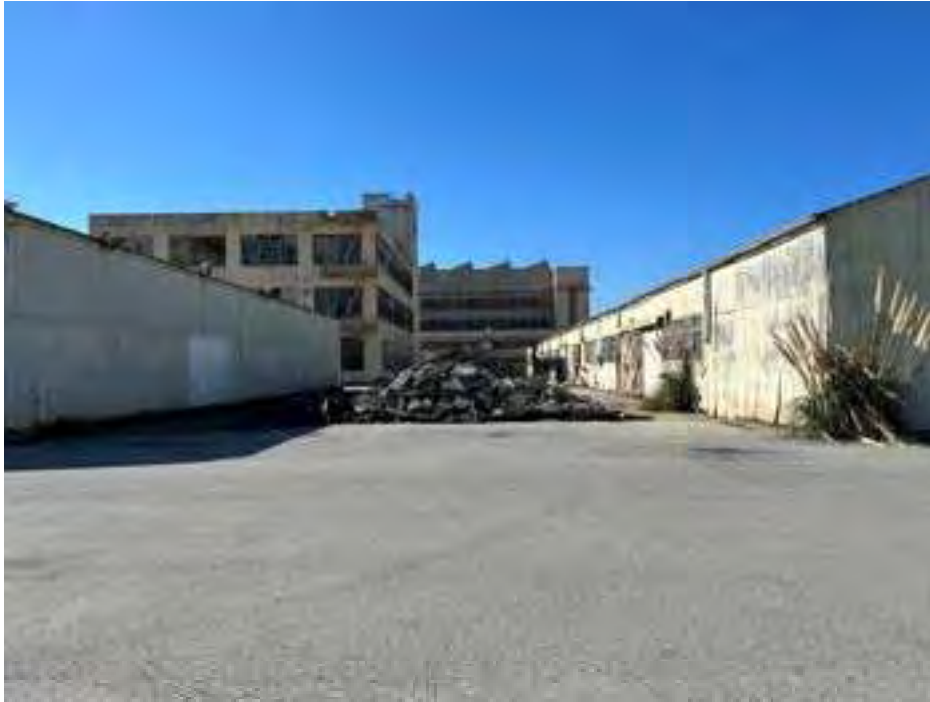
Parcel G Photograph 13: *Stockpile between Building 415 and Building 366. Facing west.*
Photographed by: Marcella Navas/CH2M, 2/9/2023

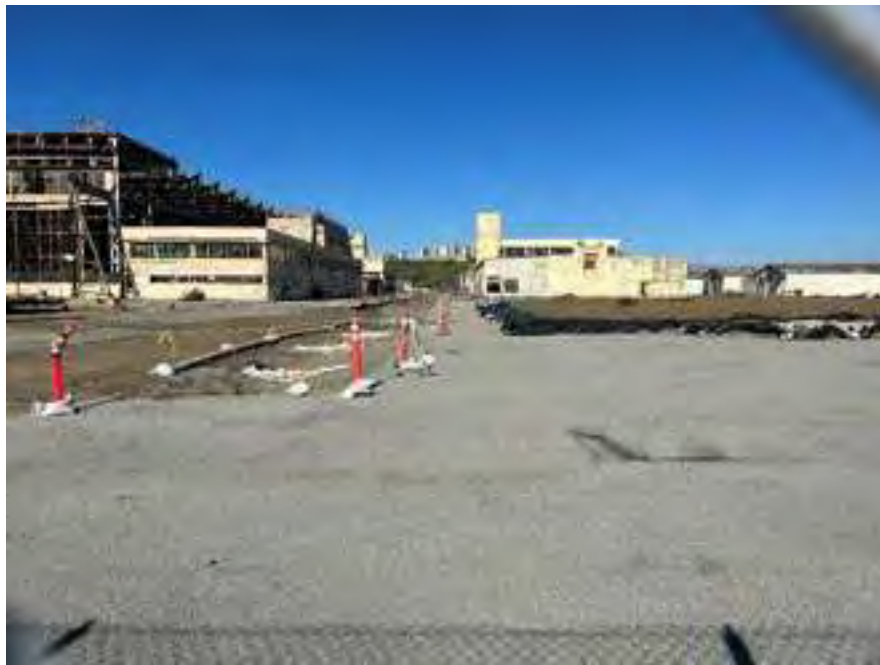
Parcel G Photograph 14: *Asphalt pavement cover, trenching, and stormwater best management practices southeast of Building 411. Facing northwest.*
Photographed by: Marcella Navas/CH2M, 2/9/2023

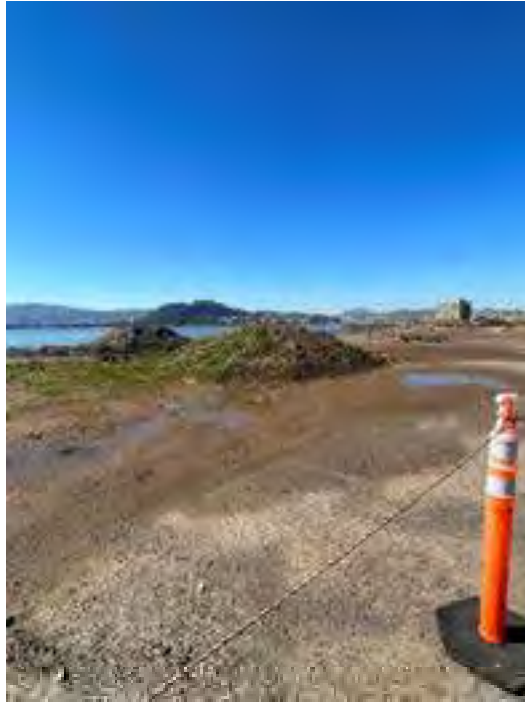
Parcel E Photograph 1: Soil stockpile at the intersection of J and Mahan Street with delineator barricading. Facing southwest.

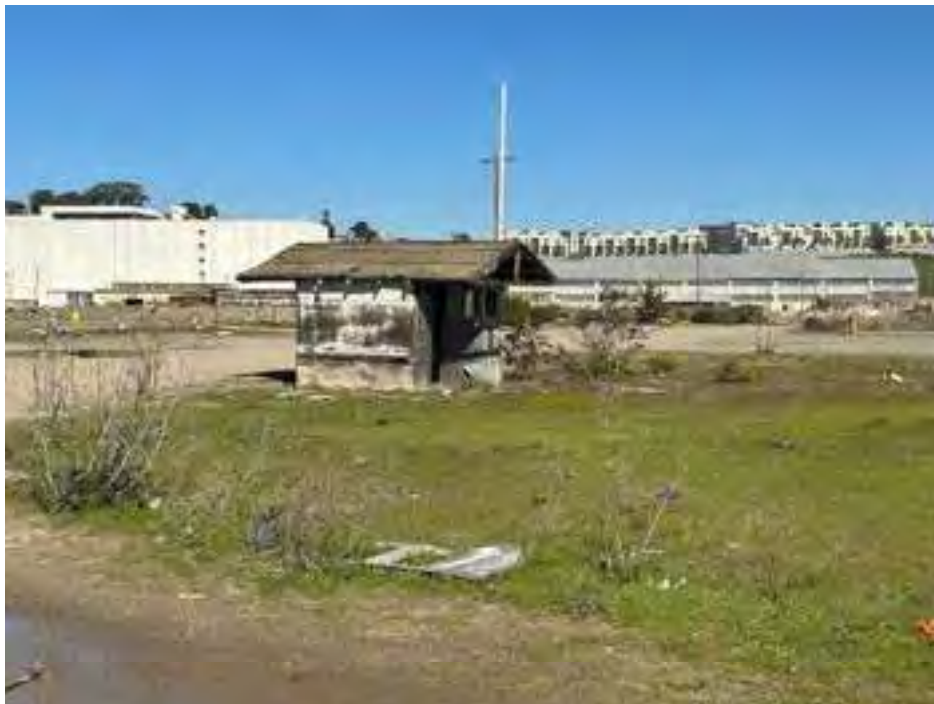
Parcel E Photograph 2: Shack on the corner of J Street and 6th Avenue. Facing northwest.

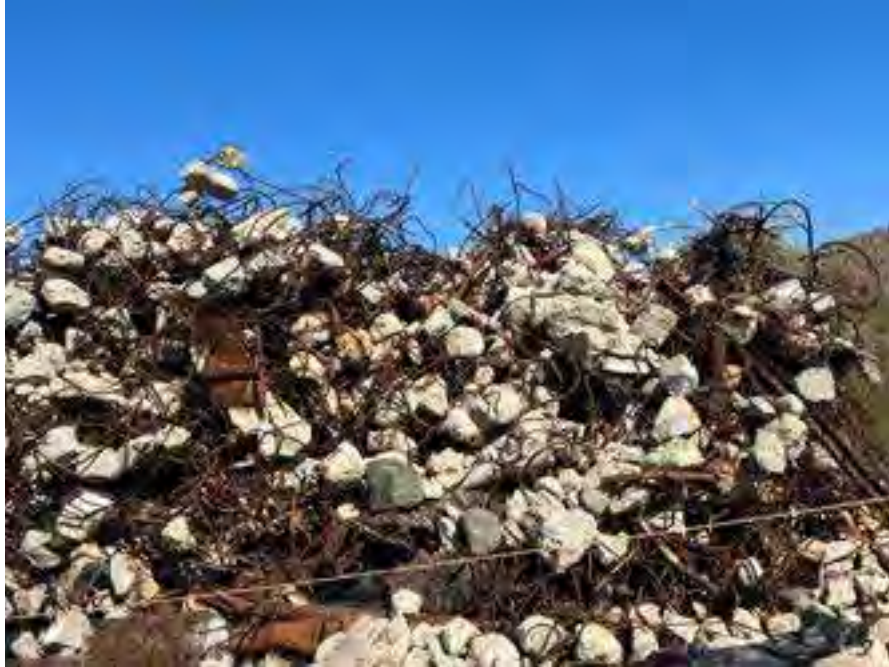
Parcel E Photograph 3: Construction debris. Facing southeast.

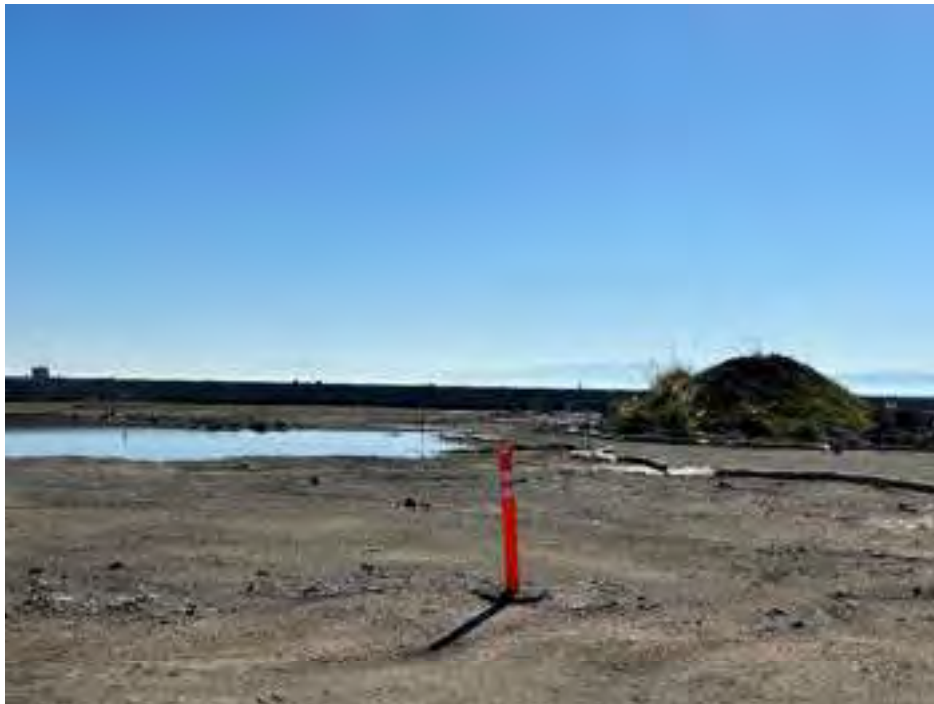
Parcel E Photograph 4: Stockpile with standing water adjacent. Facing southeast.

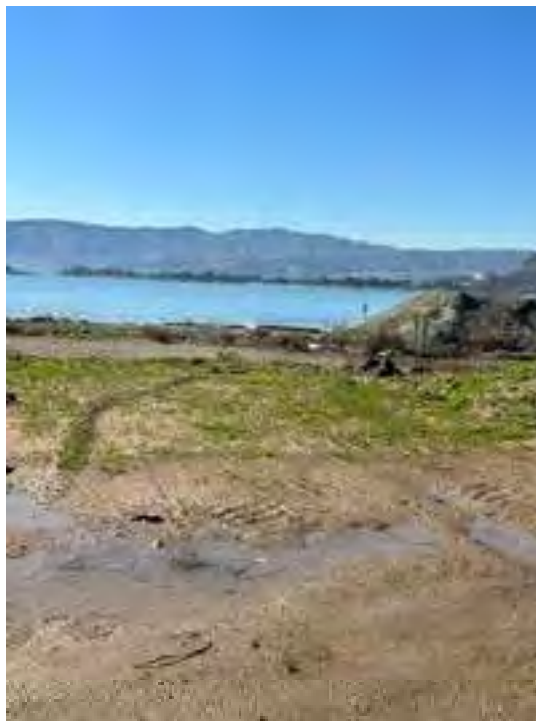
Parcel E Photograph 5: Stockpile with standing water at corner of J and Mahan Street. Facing southwest.

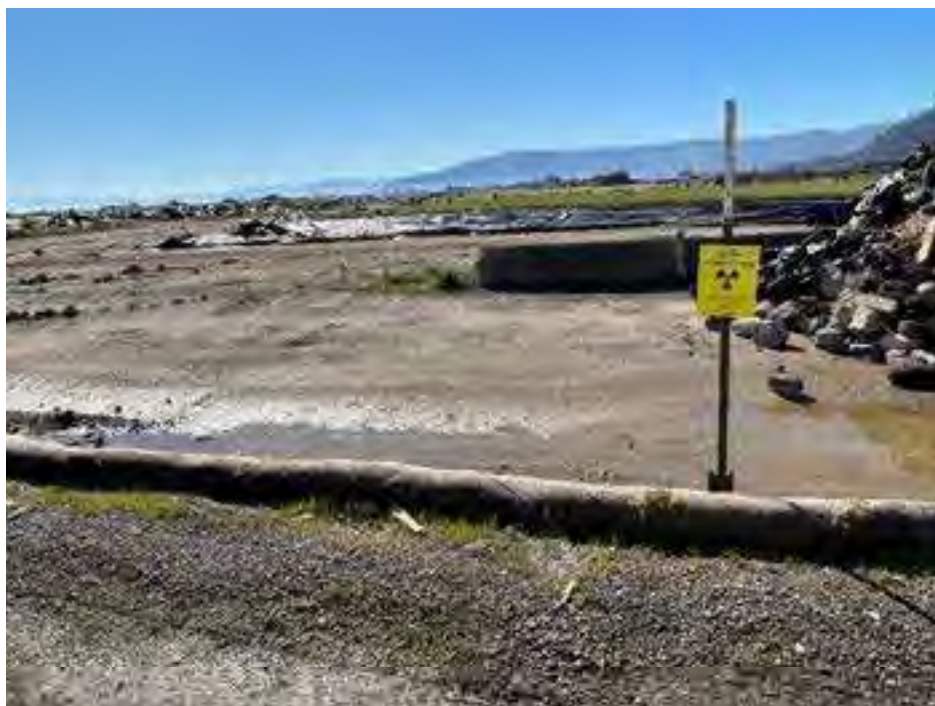
Parcel E Photograph 6: Restricted Area signage, stockpile, and best management practice on the corner of 6th Avenue and J Street. Facing southeast.

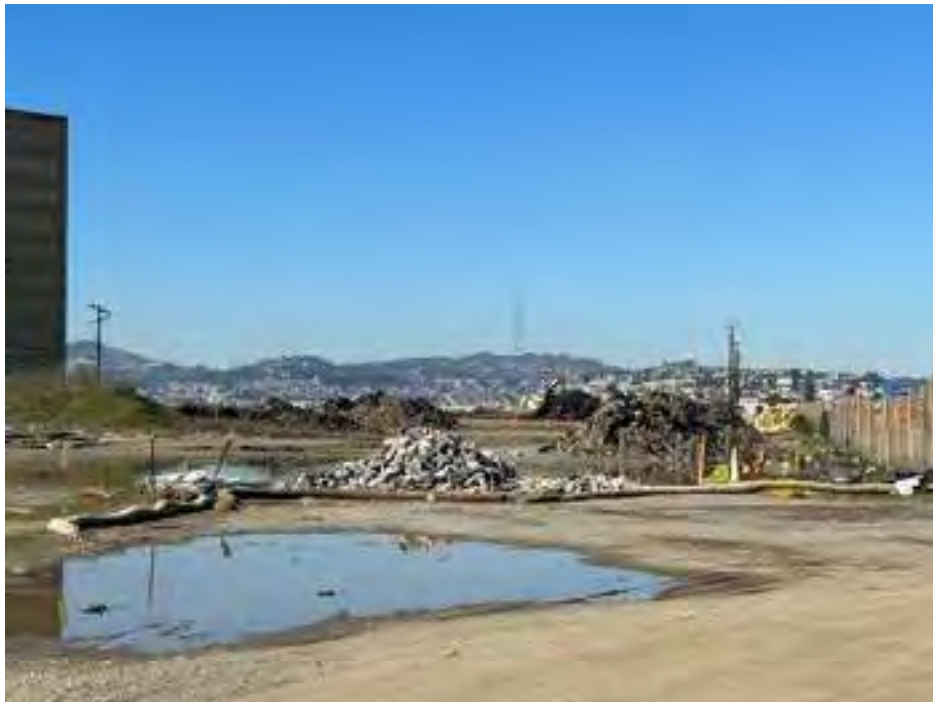
Parcel E Photograph 8: Stockpiles along fence line. Facing southwest.

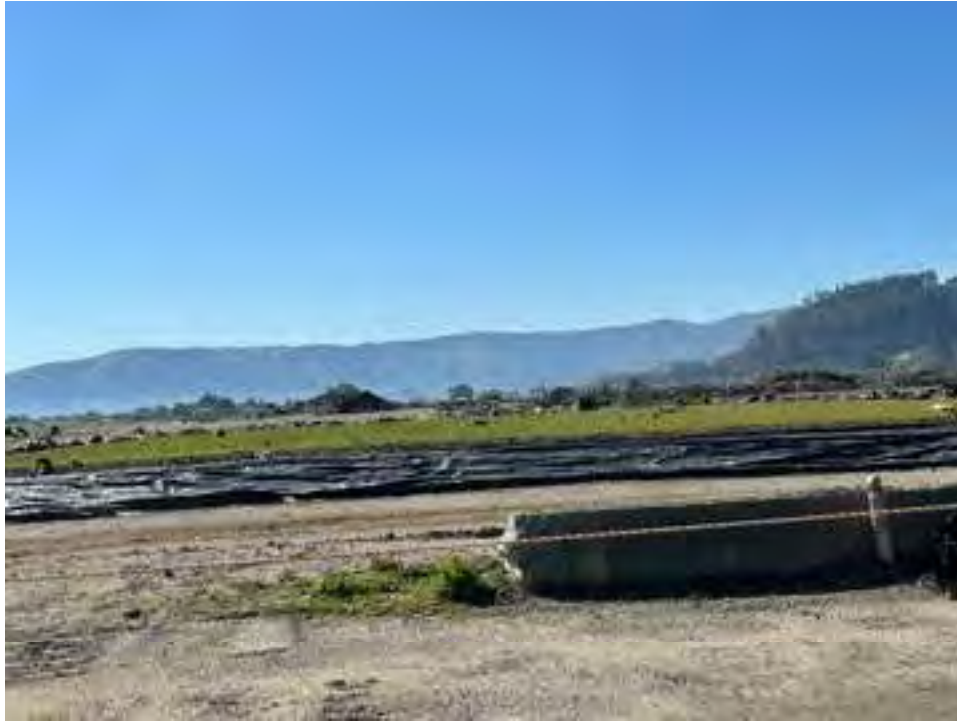
Parcel E Photograph 9: Stormwater management best management practices along corner of J Street and 6th Avenue. Facing southeast.

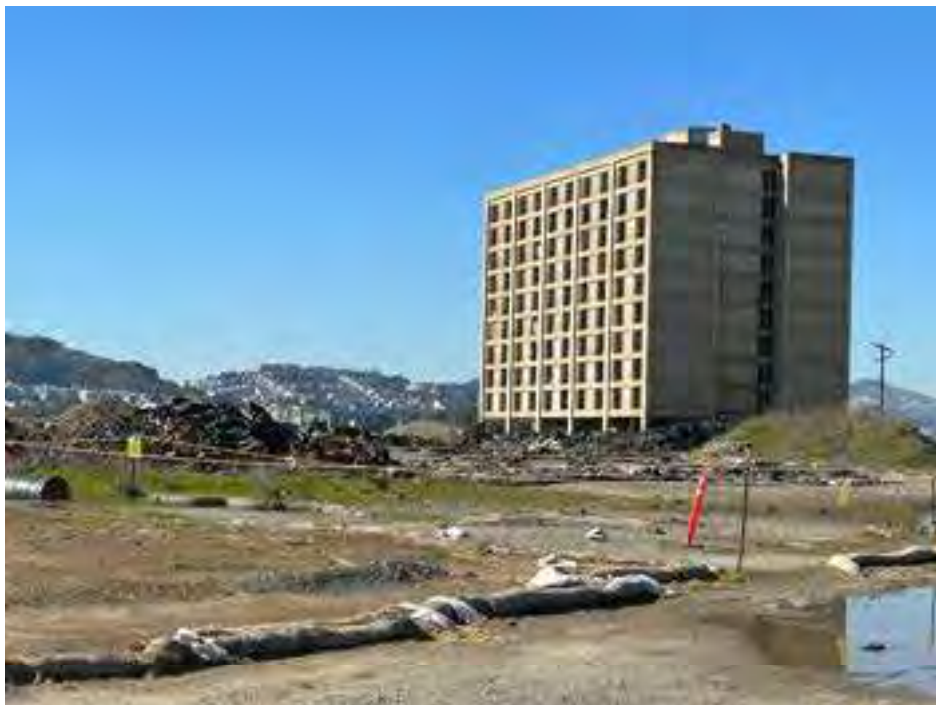
Parcel E Photograph 10: Building 521 with cordoned work area and warning signs. Facing southwest.

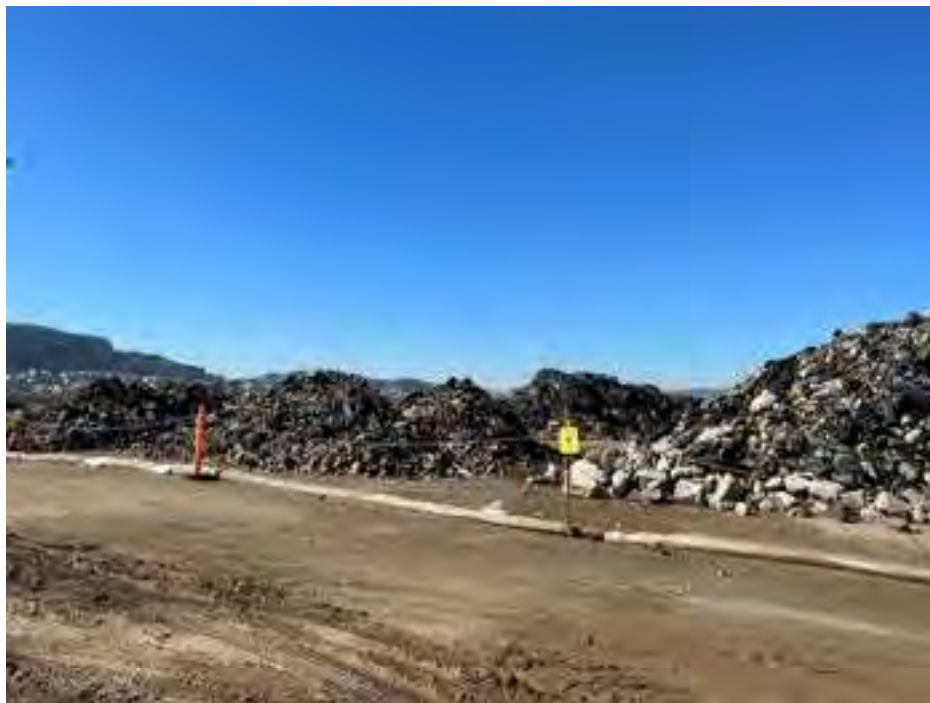
Parcel E Photograph 11: Stockpiles with warning signage and sediment control berms along 6th Avenue. Facing southwest.

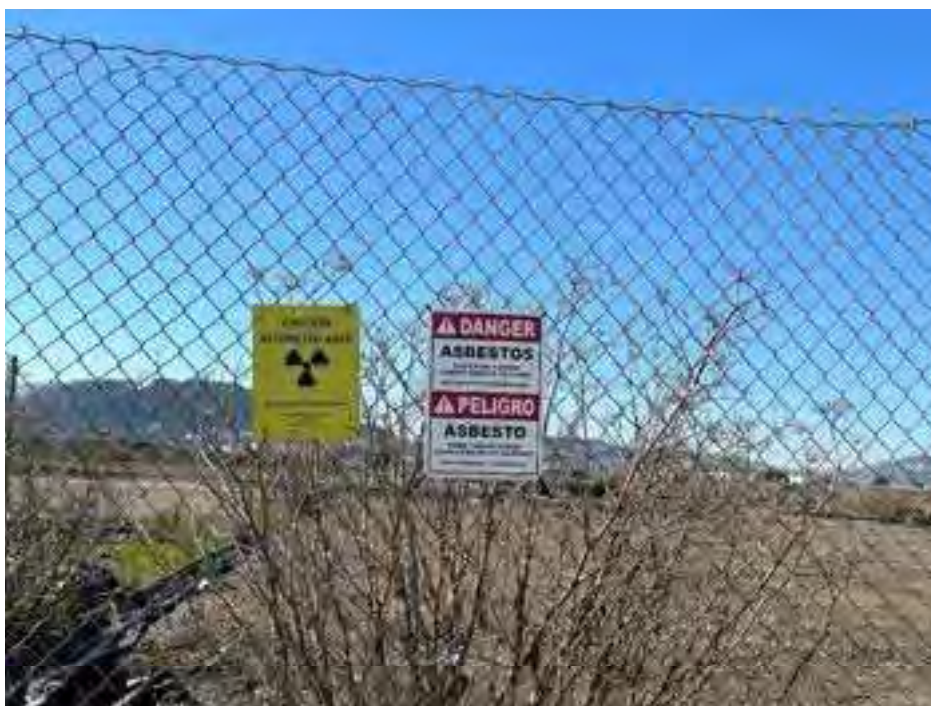
Parcel E Photograph 12: Caution and danger signs along fence line adjacent to H Street. Facing southwest.

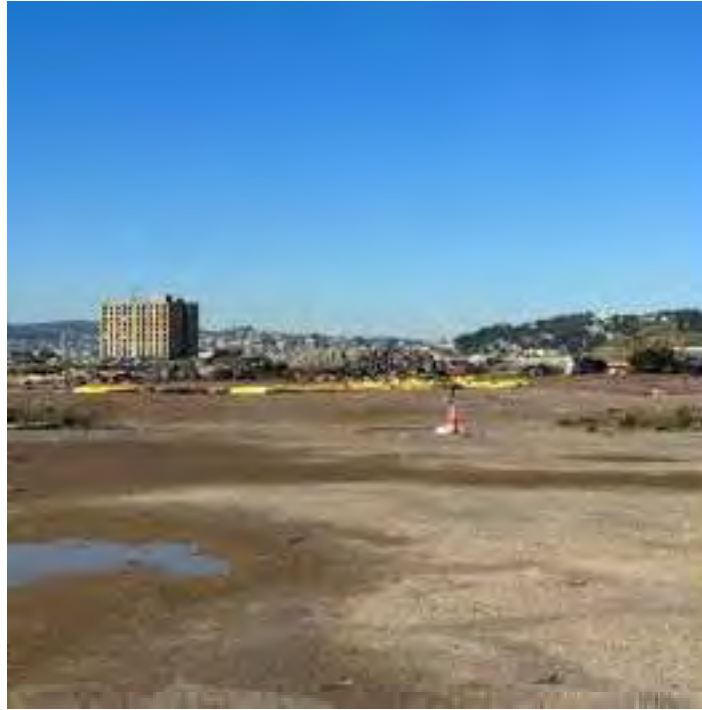
Parcel E Photograph 13: Overview of northeast end of Parcel E. Facing southwest.
Photographed by: Marcella Navas/CH2M, 2/9/2023

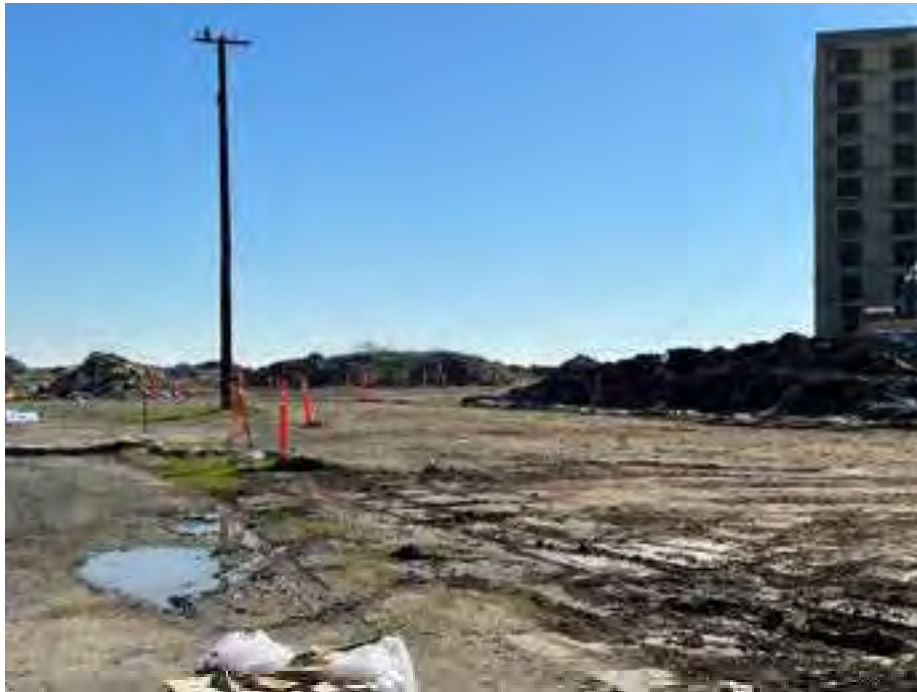
Parcel E Photograph 14: Overview of active construction area. Facing northeast.
Photographed by: Marcella Navas/CH2M, 2/9/2023

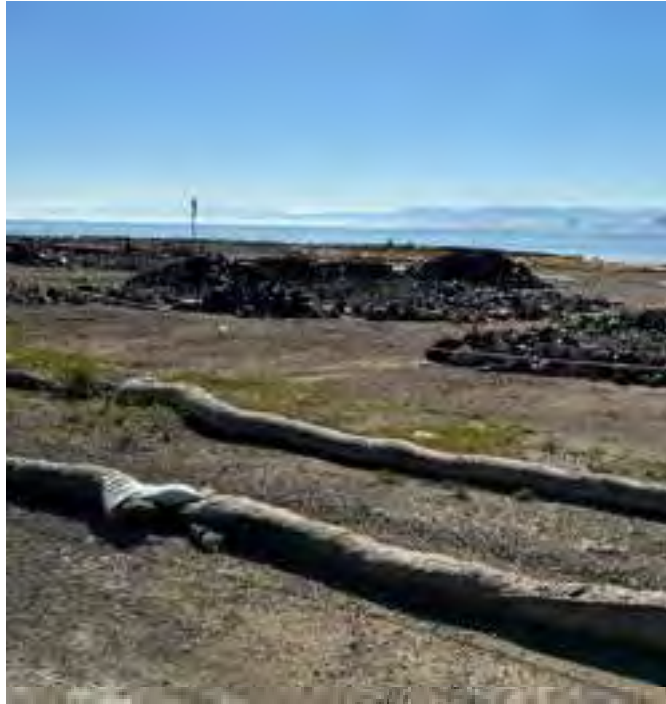
Parcel E Photograph 15: Stockpiles along embankment. Facing southeast.
Photographed by: Marcella Navas/CH2M, 2/9/2023

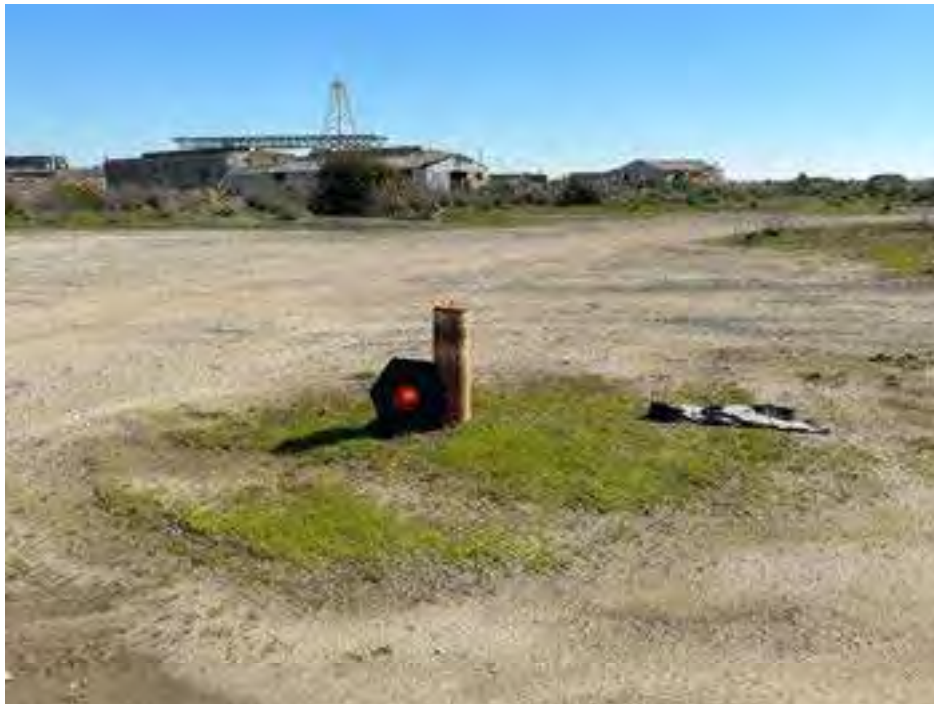
Parcel E Photograph 16: Monitoring well intact and in good condition. Facing northeast.
Photographed by: Marcella Navas/CH2M, 2/9/2023

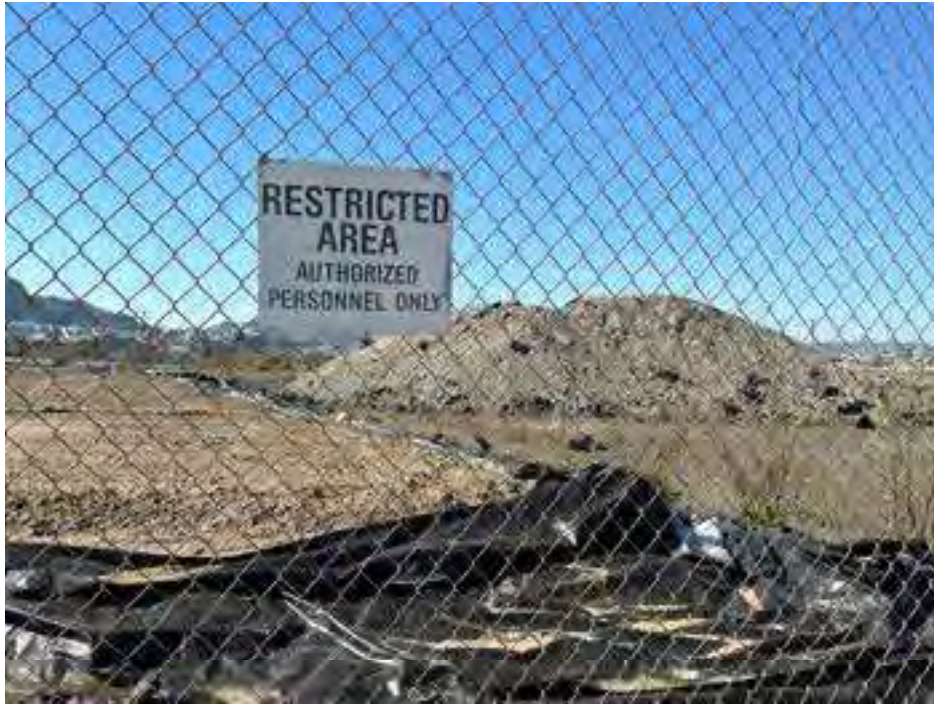
Parcel E Photograph 17: Restricted area signage. Facing southwest

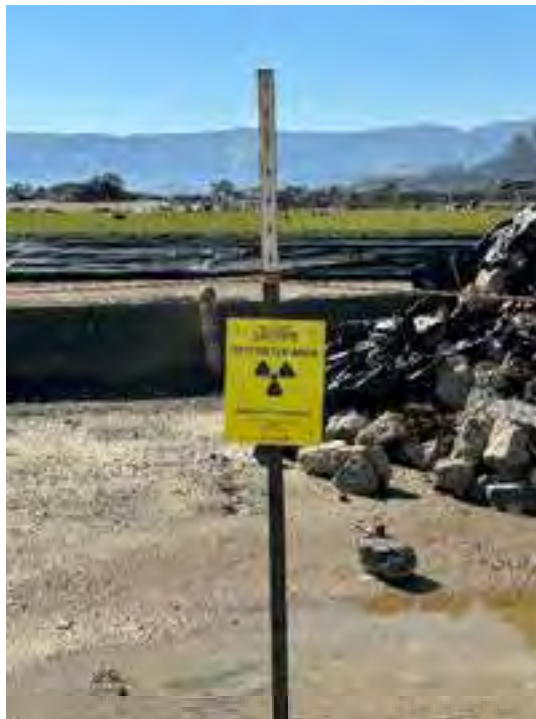
Parcel E Photograph 18: Caution sign around active work. Facing southeast.

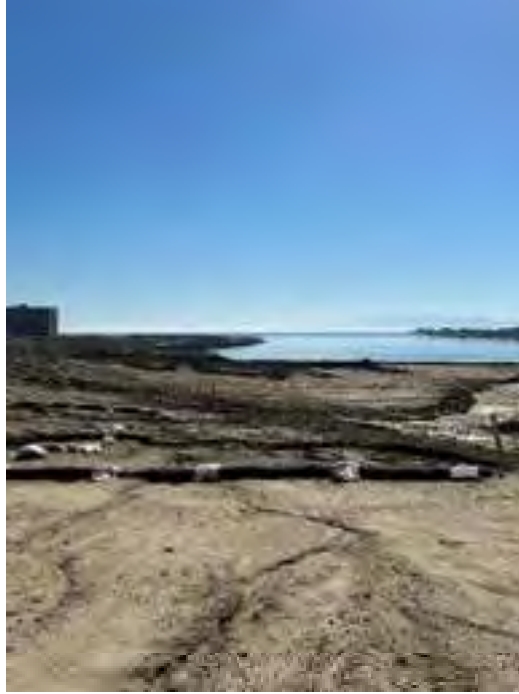
Parcel E-2 Photograph 1: Active construction with stormwater best management practices. Facing southeast.

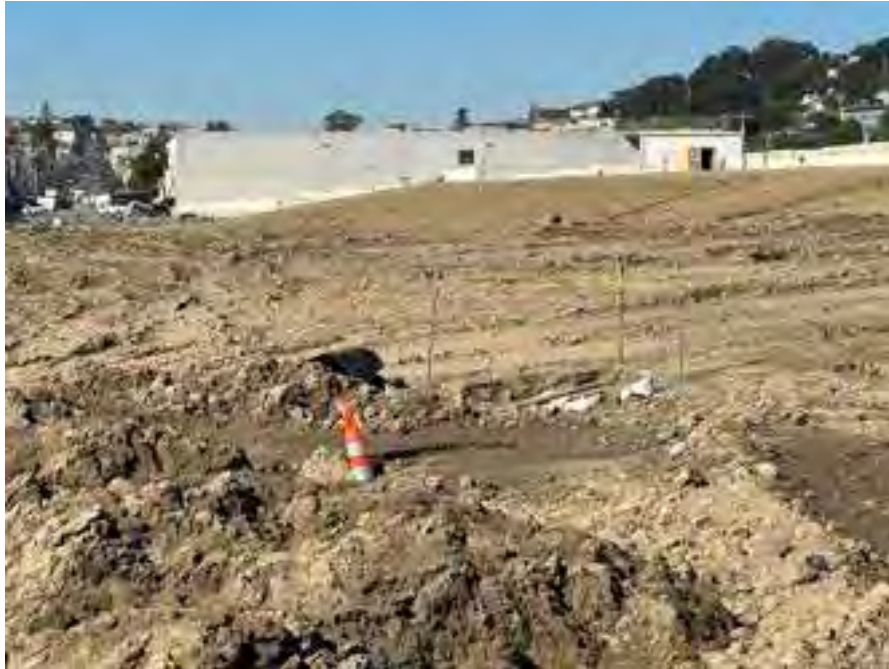
Parcel E-2 Photograph 3: *Small excavated area within soil cover construction area. Facing southwest.*

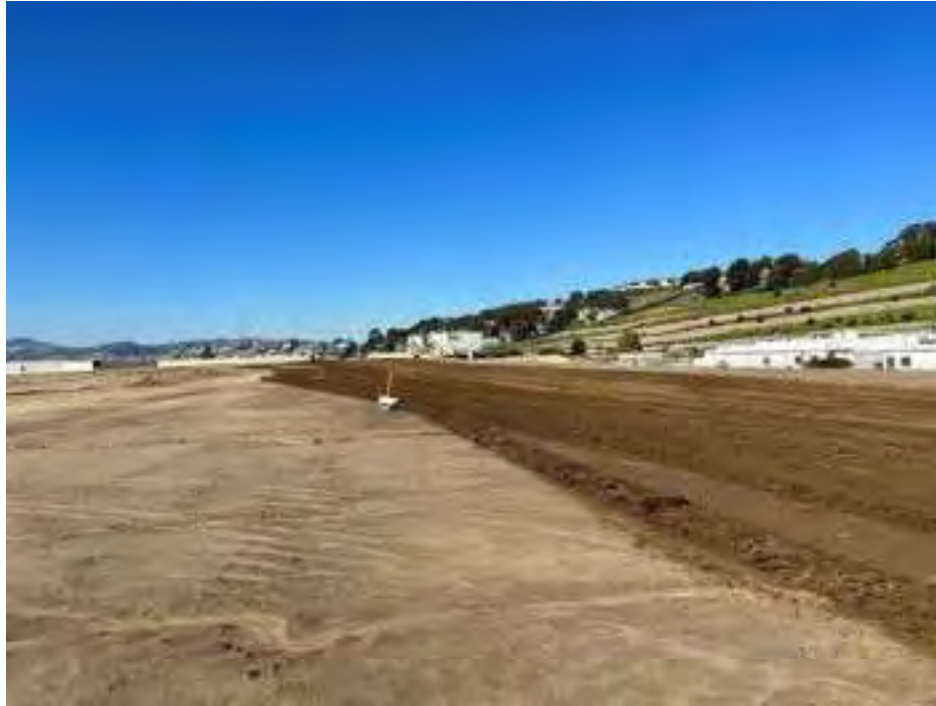
Parcel E-2 Photograph 5: Graded area with marked monitoring point. Facing southeast.
Photographed by: Marcella Navas/CH2M, 2/9/2023

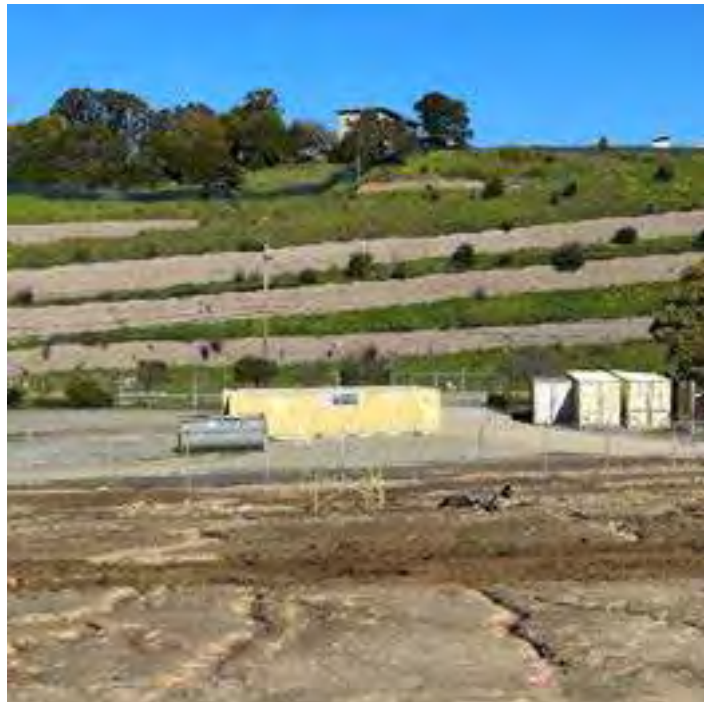
Parcel E-2 Photograph 6: Storage containers and laydown area. Facing west.
Photographed by: Marcella Navas/CH2M, 2/9/2023

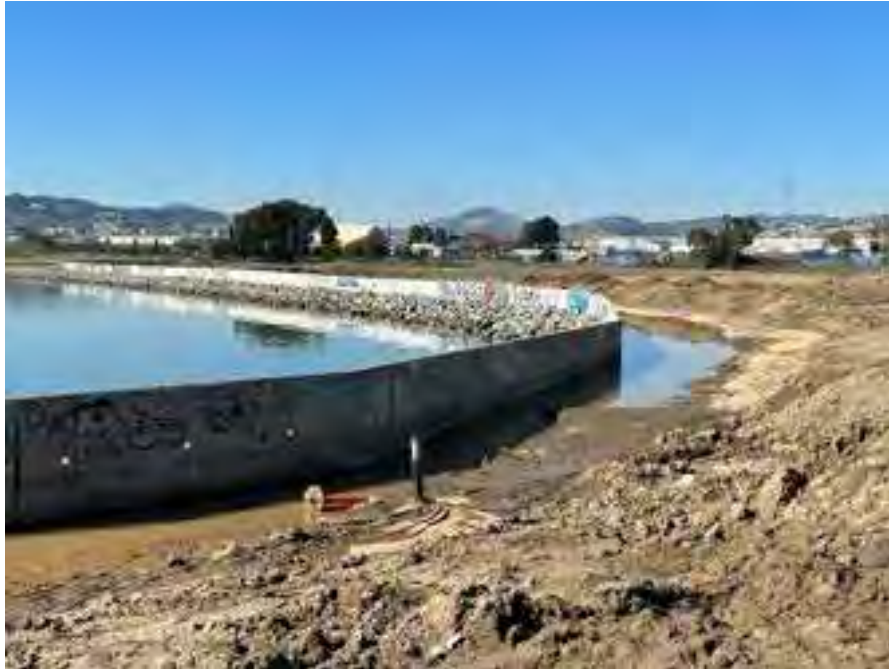
Parcel E-2 Photograph 7: Accumulated water and monitoring well adjacent to shoreline revetment and seawall. Facing southwest.

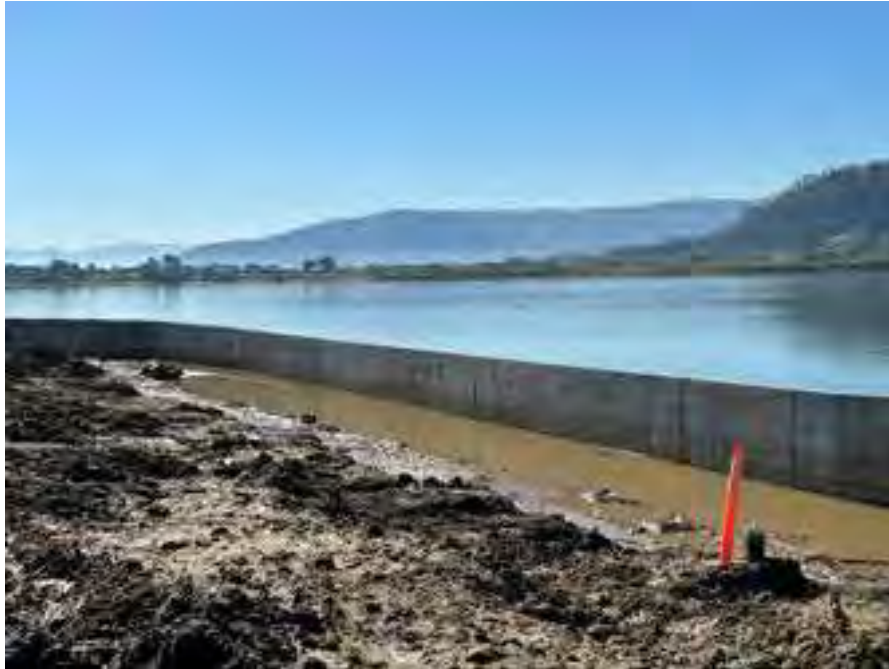
Parcel E-2 Photograph 9: Accumulated water behind seawall in active construction area. Facing southeast.

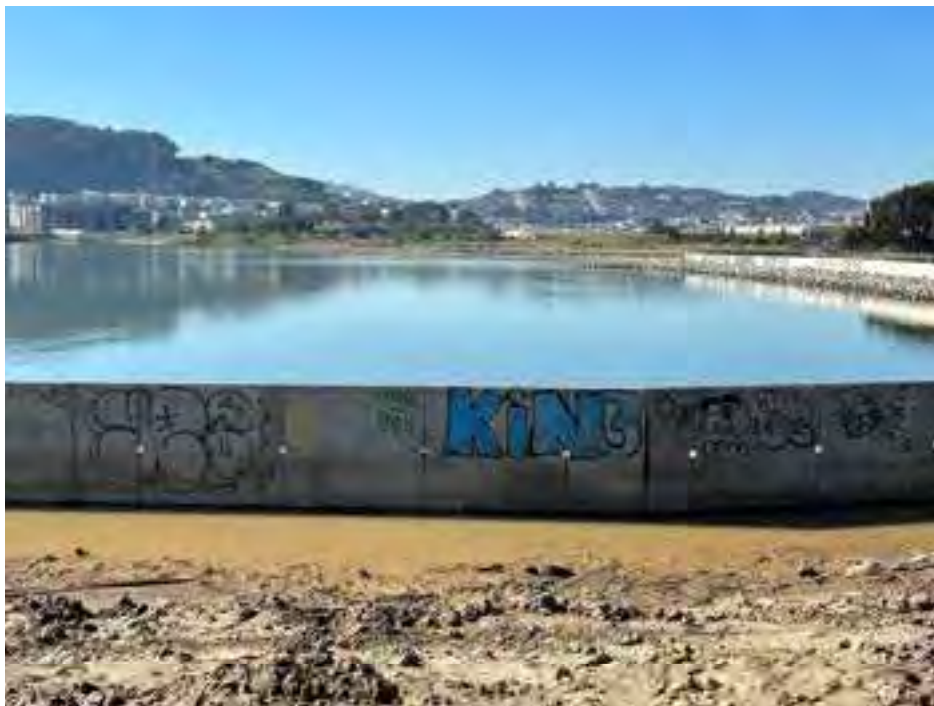
Parcel E-2 Photograph 10: Graffiti along seawall. Facing southwest.

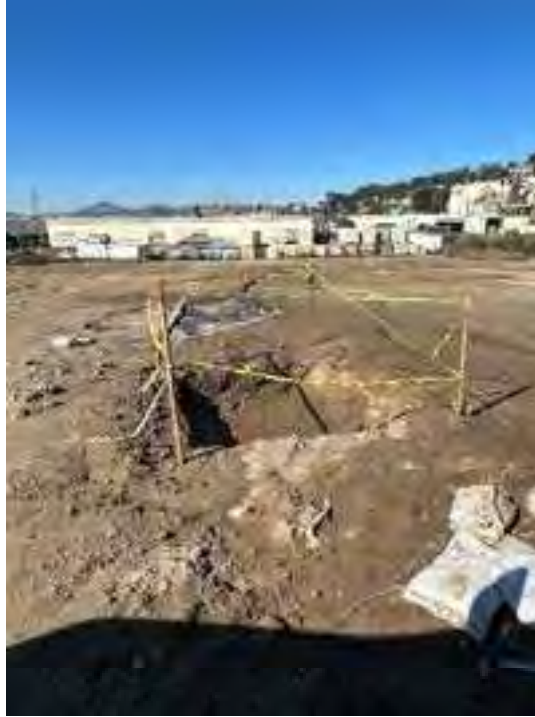
Parcel E2 Photograph 11: Small excavated area with sandbags. Facing southwest.
Photographed by: Marcella Navas/CH2M, 2/9/2023

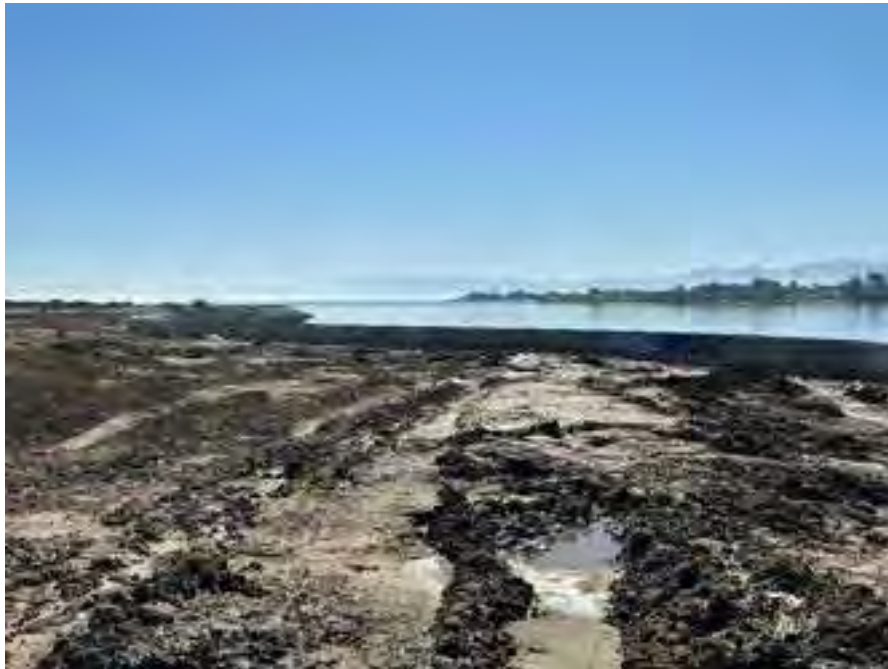
Parcel E-2 Photograph 12: Active soil cover construction area with seawall in the background. Facing southeast.
Photographed by: Marcella Navas/CH2M, 2/9/2023

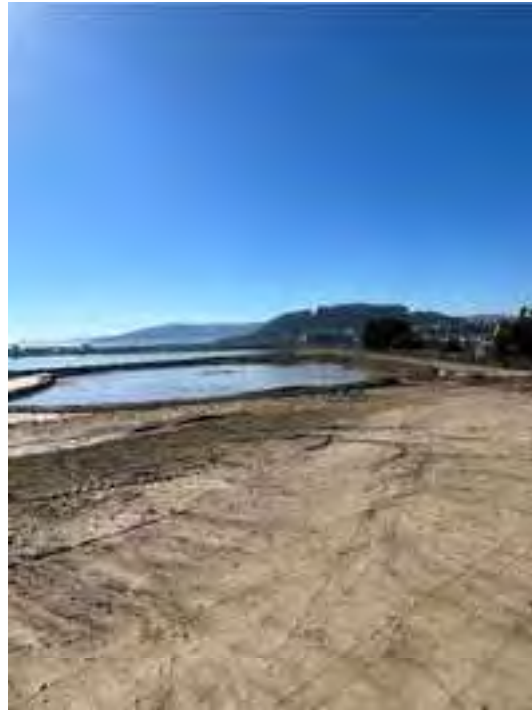
Parcel E-2 Photograph 13: Accumulated water within retention area, active construction site. Facing southwest.

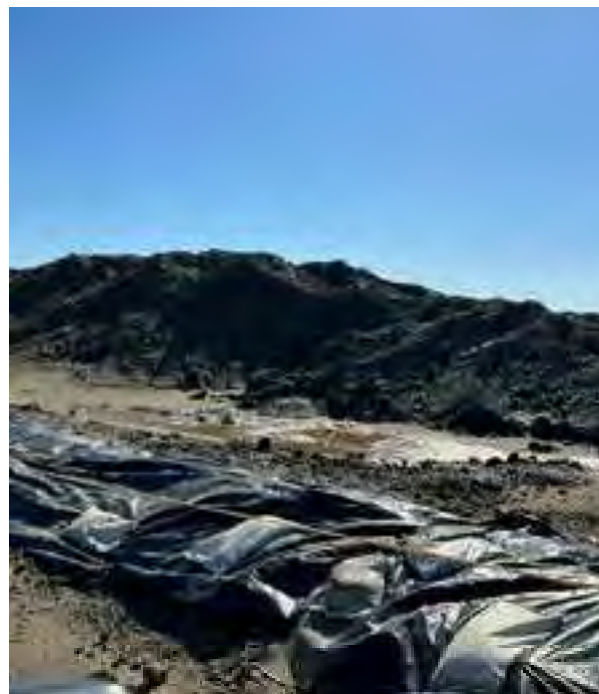
Parcel E-2 Photograph 14: Stockpile along J Street surrounded by stormwater best management practices. Facing southeast.

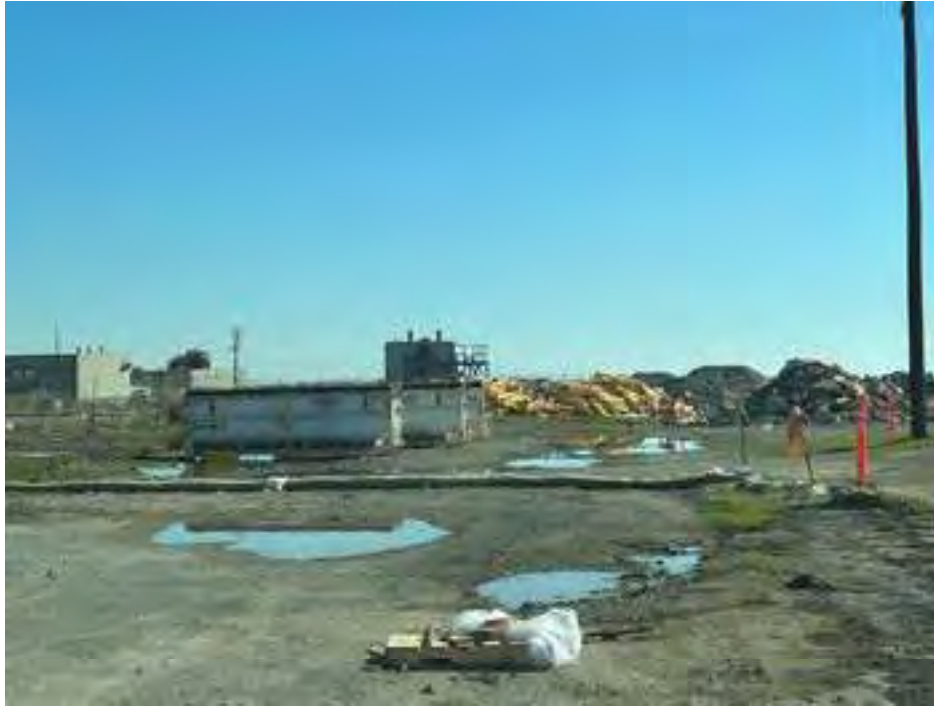
Parcel E-2 Photograph 15: Stockpiles along J Street with swale surrounding. Facing northeast.
